**Second Avenue Subway  
72<sup>nd</sup> St. Station Cavern Mining Contract (C-26007)  
Summary Report of August 21, 2012 Incident at Ancillary No. 2**

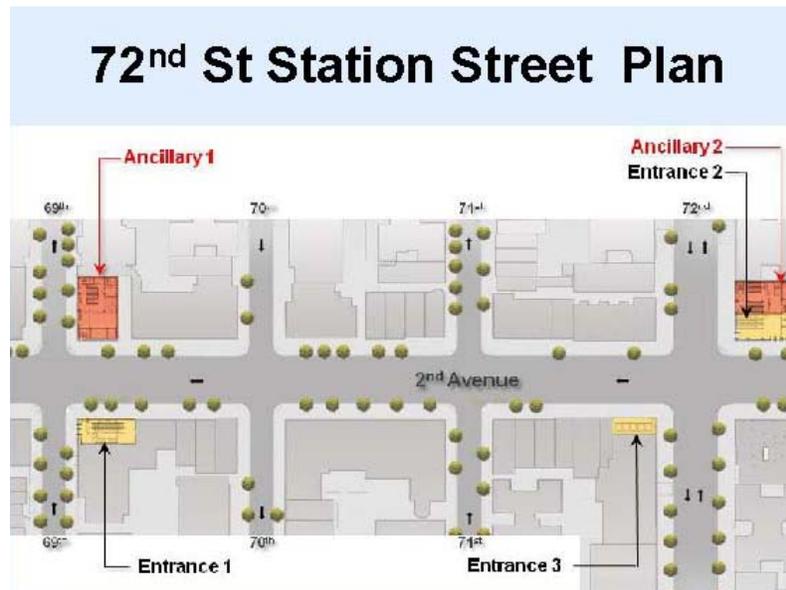
The scope of this contract includes the excavation of a shaft of approximately 74 feet by 74 feet at the surface using drill and blast construction at the site for the Ancillary 2 Building (see figure below). This site will ultimately be an entrance to the subway below and a ventilation facility for the station.

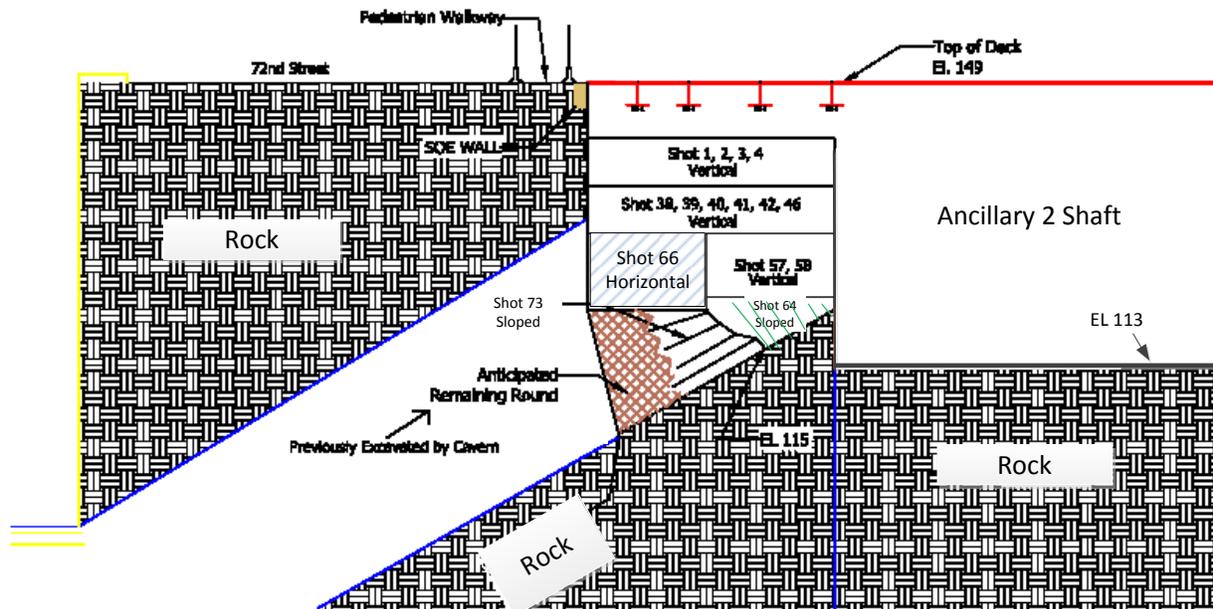
### Section View Escalator Excavation Sequence Prior to Shot #73

The drill holes for this blast, and two prior blasts which went off without incident, were not drilled vertically as required under the approved plans (shots #64 and #66). The CCM should have recognized that these three blasts did not meet the requirements of the approved plans and the blasts should not have been allowed to proceed. MTACC's engineer (AAJV) confirmed that the use of angled or horizontal drilling was not contemplated in the approved plans.

1. Improper blast timing sequence causing excessive blast force.
2. Orientation of the drilled holes, which were inclined (i.e. angled) rather than vertical.
3. Use of 10-12 foot long blast holes which may have not been drilled properly (i.e. in parallel).
4. Sloped condition of the rock and inadequate rock cover.
5. Failure of the decking system to contain the fly rock.

The unanticipated focus of blast energy upwards, rather than horizontally caused the shifting of two sections of the steel deck plates. This resulted in the release of rock, smoke and dust from the shaft into the 72<sup>nd</sup> Street road surface and the surrounding public area. The steel decking system that SSK used to prevent fly rock from exiting the shaft, did not consider the uplift pressure caused by the use of non-vertically drilled blast holes. Furthermore, the steel plates were not fully anchored to the steel girders and concrete support wall.

- A superintendent will check that the blast area has been prepared in accordance with the approved plan and sign the pre-blast checklist. This will include checking all drilled holes in their final state for diameter, depth, orientation; and provide a completed checklist to the CCM prior to proceeding with any blast operation.
- A second licensed blaster will be required for each blast to verify that the blast has been prepared in accordance with the approved plan.
- The blast plan must be documented with each individual blast.
- The steel decking system must be supported by design drawings and calculations demonstrating its ability to withstand uplift pressure.
- For all blast events in ancillary and entrance shafts, a minimum of a double layer of overlapping blast mats must be used over the blast area.
